American Energy Systems, Inc.

## TECHNICAL BULLETIN

Magnum Baby Countryside & Winchester AC/DC Models

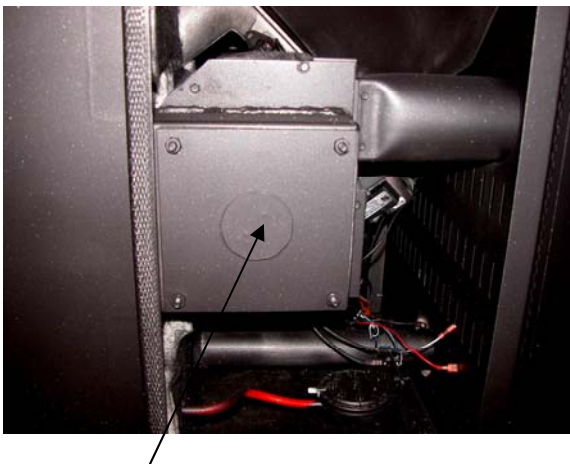
1. Cleanout plug is hard to get off inspection hole on the side of the exhaust manifold housing.
2. Combustion air clean out plug in back of ash pan housing is loose.

Remove plug with screwdriver and discard  
Replace with new one. Part# RP2094
